Muck Reduced 2.4' in 3 Years - An Independent Study on the Effectiveness of Vertex Aeration to Eliminate Accumulated Sediment

Lewiston's East Twin Lake Develops An Aeration System

East Twin Lake Aeration Study

Aeration of East Twin Lake Sediment, BOD and Oxygen Results

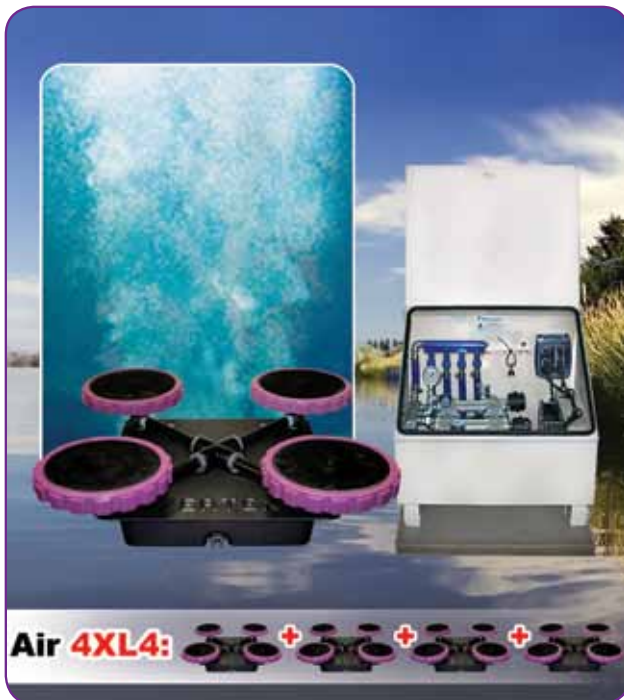
Eight Vertex Air3 XL4™ Systems installed at East Twin Lake Cove

The Vertex Air3 XL4™ pond aerator is a super-efficient, affordable and safe system. In a typical pond, an Air3 XL4™ can aerate approximately 4-7 acres depending on shape, slope, oxygen demand and other factors. Two 1/2hp (0.75kW) Brookwood™ SafeStart™ compressors, housed in our rustproof aluminum outdoor cabinet, feed three bottom mounted XL AirStations™ utilizing Vertex's MicronBubble™ technology.

The rising force of millions of bubbles circulates the entire water column, entraining bottom water up to the surface allowing vital oxygen to be absorbed and poisonous gasses expelled. With no electricity in the water, Vertex's aeration systems are safe for any type of water recreation.

- ◆ 24 XL4 AirStations: (96) 9" flexible membrane discs
- ◆ 8 QuietAir Cabinets: (16) 1/2hp Brookwood Compressors
